June 28, 2019 File No. 262018.063

Subject: Department of Natural Resources Washington Geological Survey,

School Seismic Safety Assessment Project, Contract No. AE 410 - Seismic Evaluation for **White Salmon Valley School District**

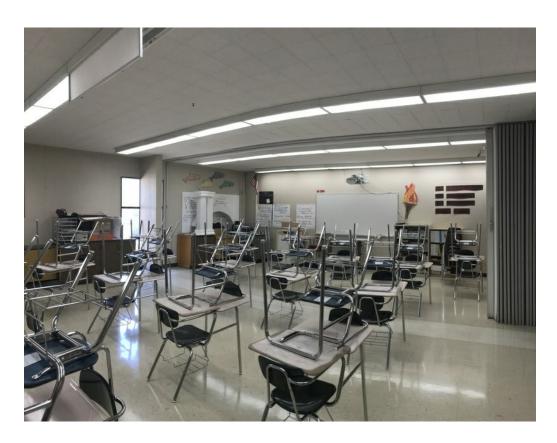
Figure 1-4. Typical Classroom with Moveable Partition

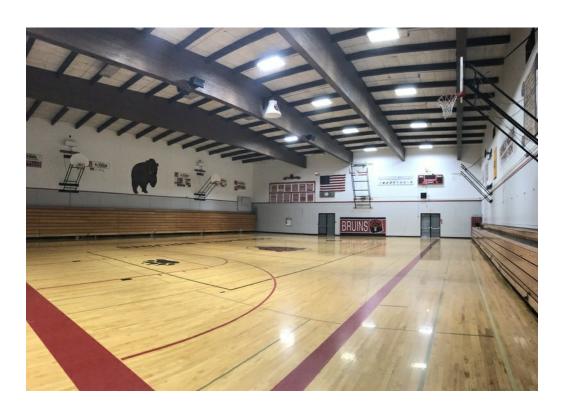
Figure 1-6. Gymnasium with Glulam Arches and Tectum Roof Panels

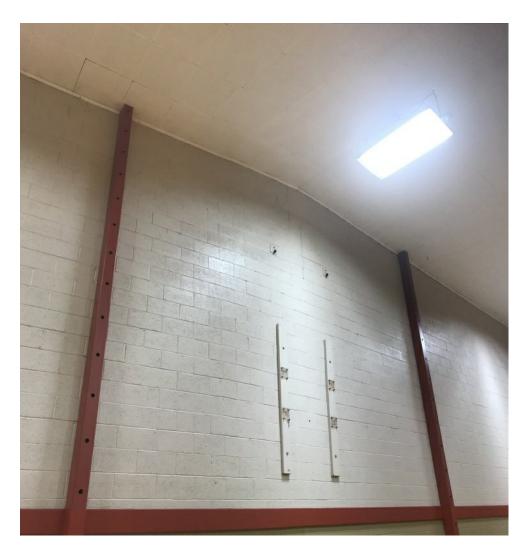
Figure 1-7. HSS Strongbacks at Gymnasium Walls

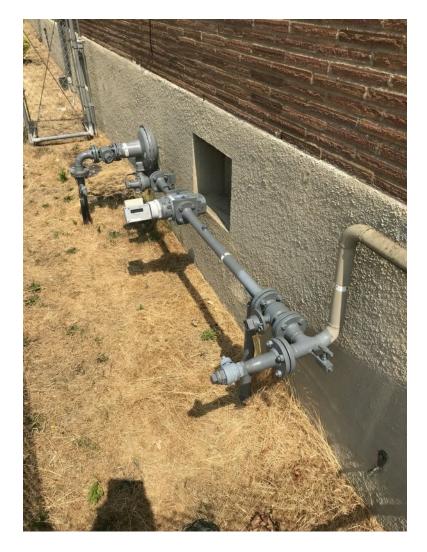
Figure 1-8. Gas Lines at Exterior

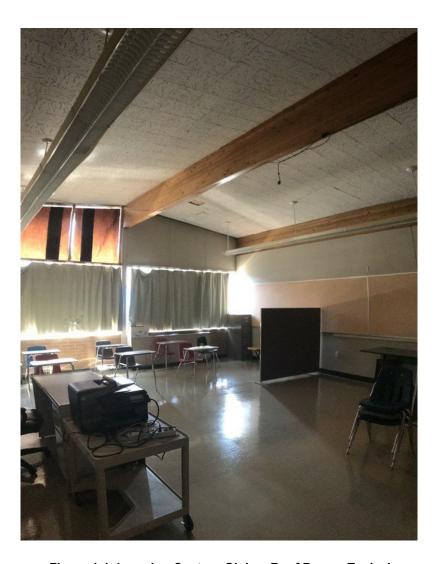
Figure 1-1. Learning Center - Glulam Roof Beams Typical

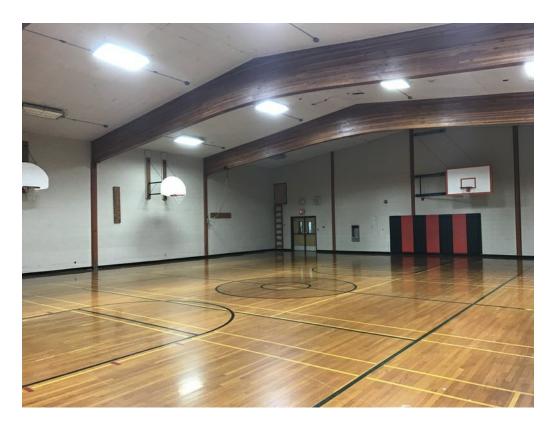
Figure 1-3. Multipurpose Room with Glulam Arches

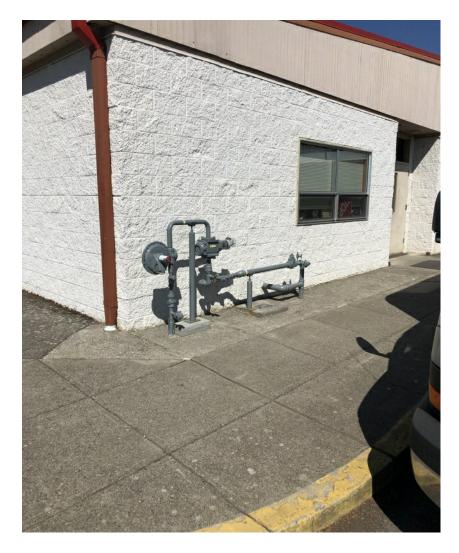
Figure 1-9. Gas Lines at South Exterior
